Predicting Erosive and Debris Flow Processes and the Innovative Measures to Control Them

Givi Gavardashvili

This book first published 2022

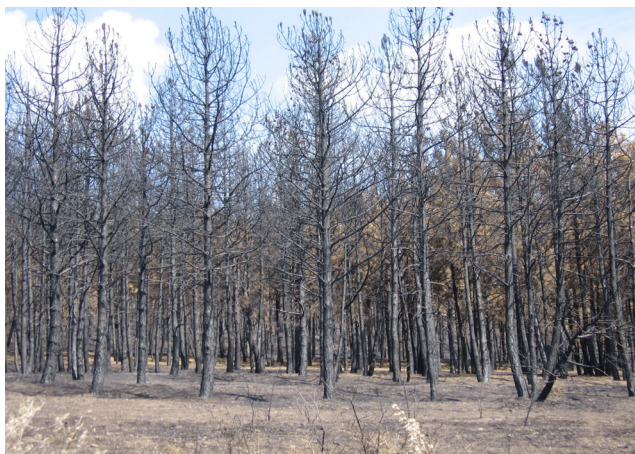
Fig. 1.1. The territory near Gori after the fire

Figure 1.1 shows the burned-down forest territory near Gori; Figure 1.2 shows the burned tree remnants in the forest of village Daba near Tsagveri; Figure 1.3 shows the burned forest massifs in village Daba; and Figure 1.4 shows the sampling process of the burned soil.

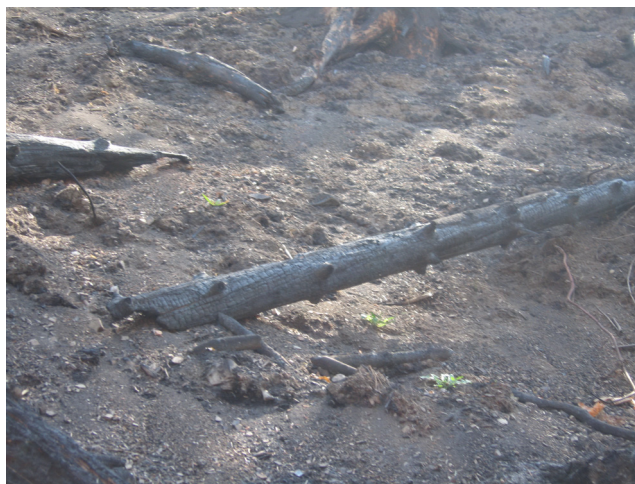
Fig. 1.2. Burned tree remnants in the forest of village Daba

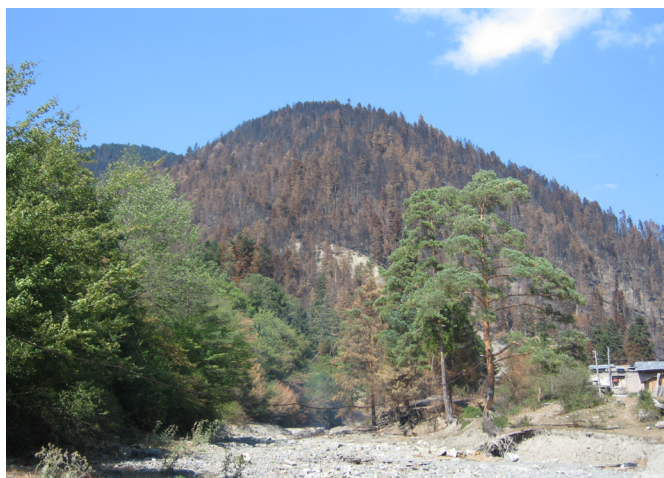
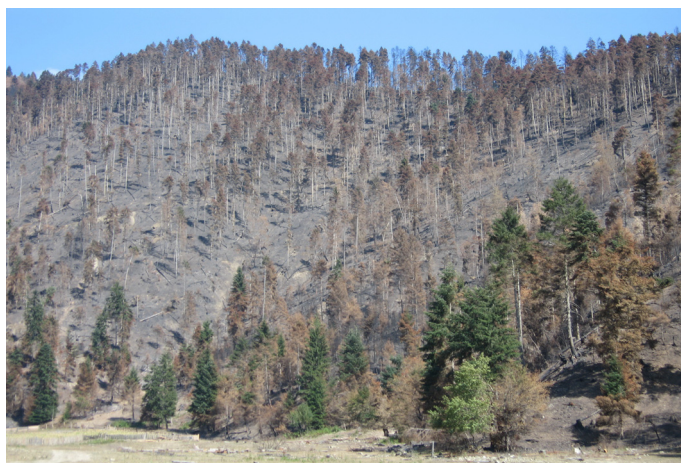
Fig. 1.3. Territory near village Daba (Tsagveri) after the fire

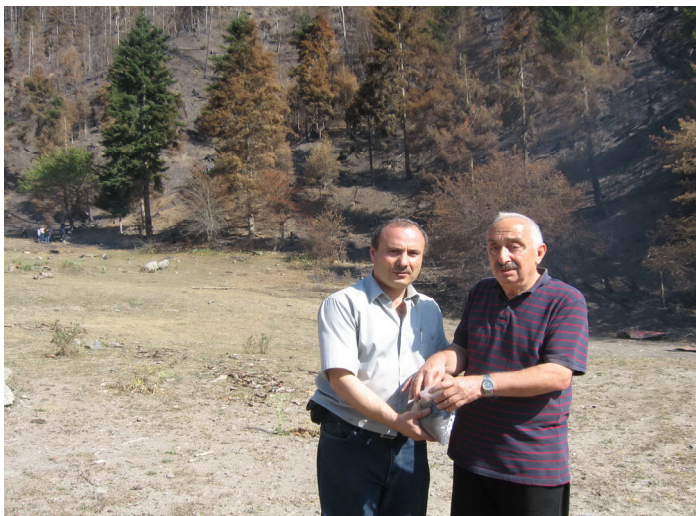
Fig. 1.4. Sampling the burned soil in the forest of village Daba (right-to-left: Prof. T. Urushadze, Prof. G. Gavardashvili)

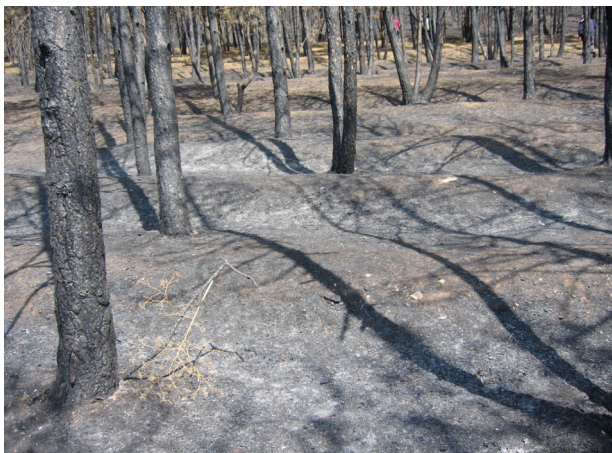
Fig. 1.5. Burned soil surface near Gori

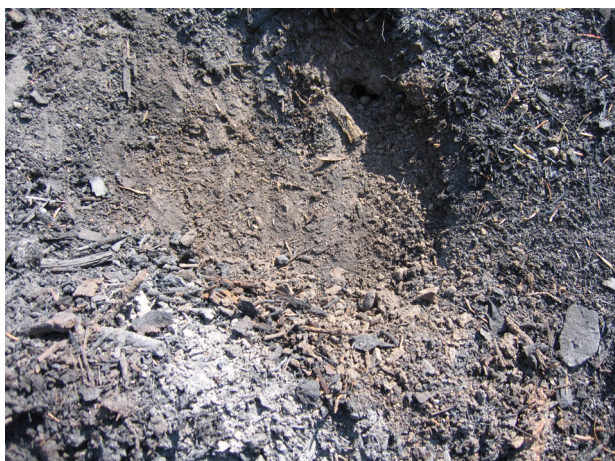
Fig. 1.6. Burned soil surface in village Daba
